FINAL RECORD NOTES

STATE HIGHWAY NO. PORT WASHINGTON NARROWS BRIDGE PROJECT

SECTION CONCRETE SUBSTRUCTURE & SUPERSTRUCTURE

CONTRACT NO. 5565, UNIT 2 FEDERAL AID NO. NONE

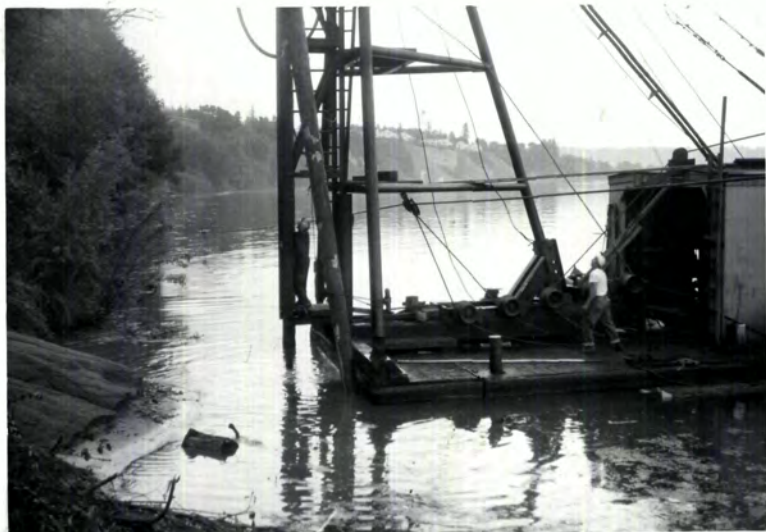
REMARKS: Pile Driver starting first  
falsework bent at North Bank.

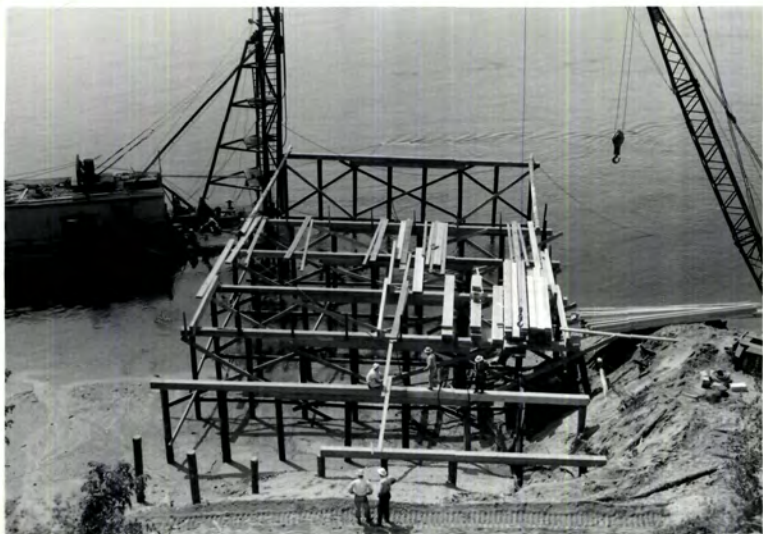
REMARKS: Falsework bents. Looking  
South from North Bank.  
Pier 9 lies between two  
furthest bents.

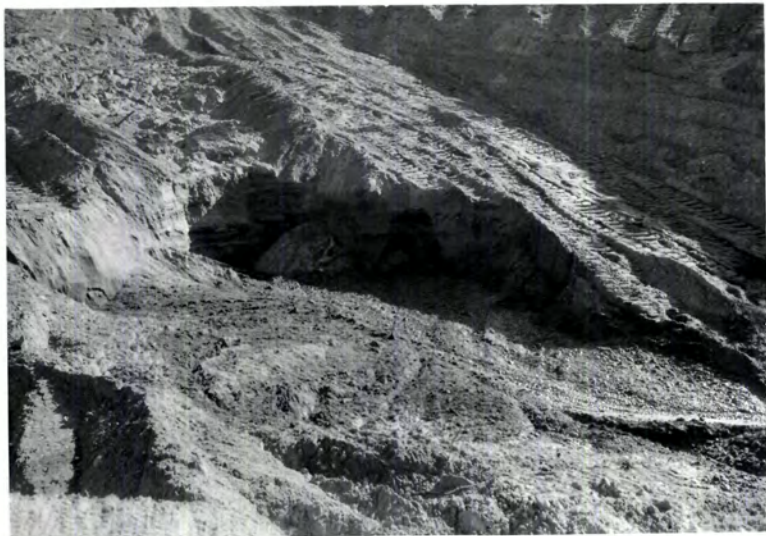
DATE: AUGUST 1, 1957  
REMARKS: Vertical scarf just North  
of Pier No. 10. Caused by  
water emitting from face of  
bank.

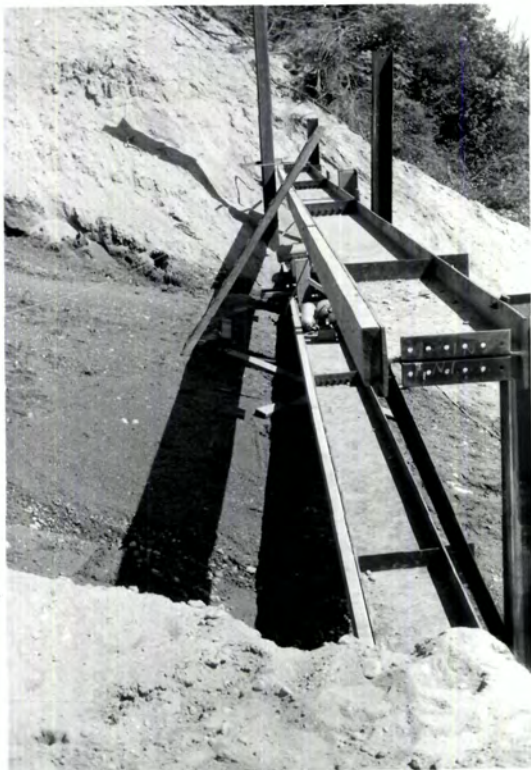
DATE: AUGUST 14, 1957  
REMARKS: First Sheet on Pier No. 10  
Cofferdam.

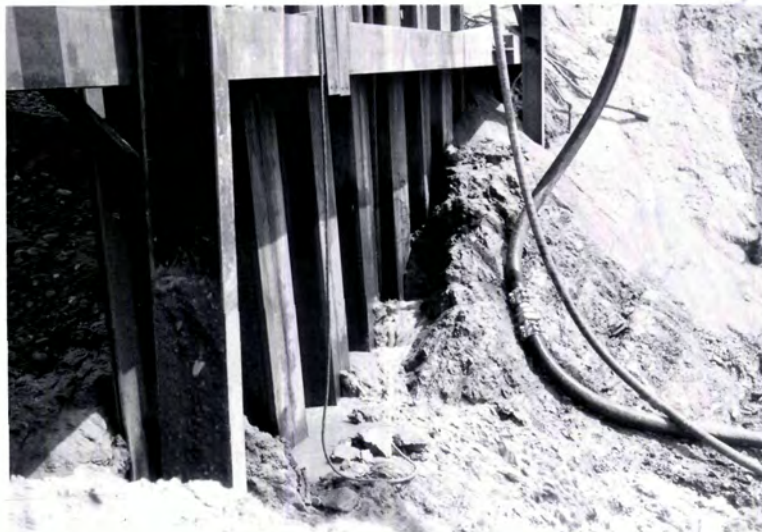
REMARKS: Frames and North Line of  
Pier 10 Cofferdam. Note  
piles forced out of line  
by material from bank.

The first cofferdam, at Pier 10 was started on August 12, 1957. This cofferdam was constructed primarily to retain the toe of the North bank while the pier footing and lower column sections were being constructed. More actual trouble was experienced on this dry land cofferdam at pier 10 than on any of the remaining seven. Ground water was emitting from the bank just north of the pier which in turn washed great quantities of material against the cofferdam; thus creating a very costly and time consuming operation. Later, a perforated drain line was installed in the area, which intercepts the ground water and has prevented further scouring of the bank.

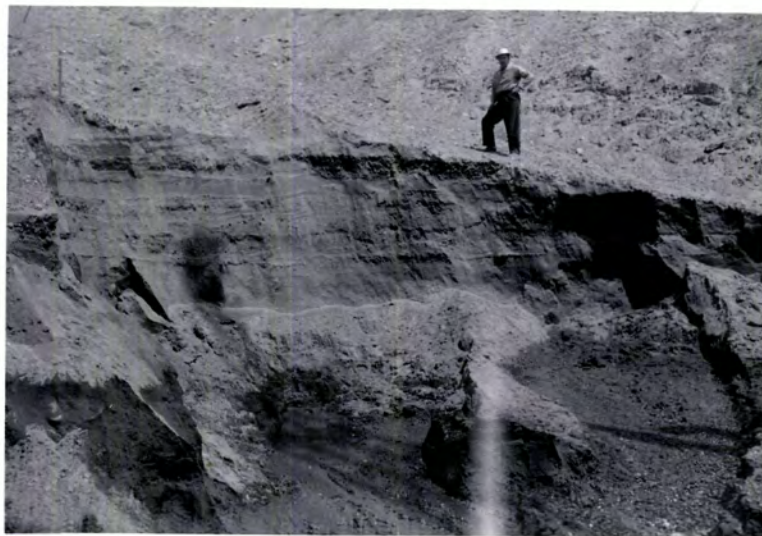
REMARKS: Vertical Scarf North of  
Pier 10 caused by water  
emitting from bank.

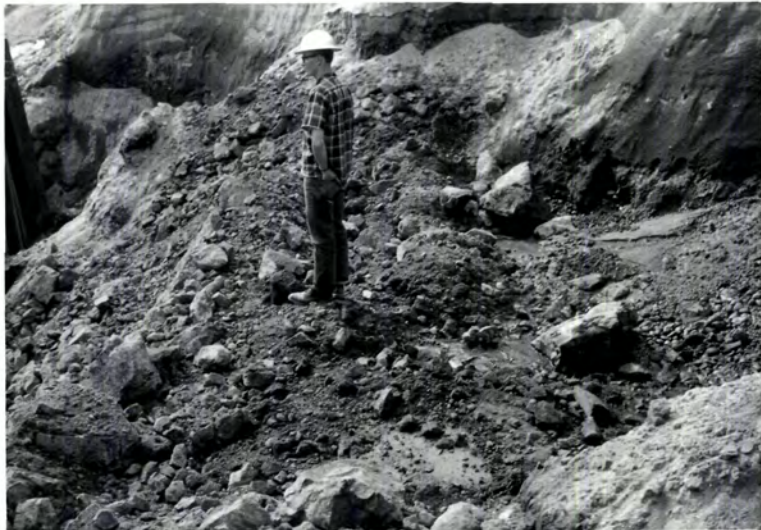
DATE: AUGUST 29, 1957  
REMARK: Riprap placed north of Pier  
No. 10 to hold fines and  
prevent bank erosion.

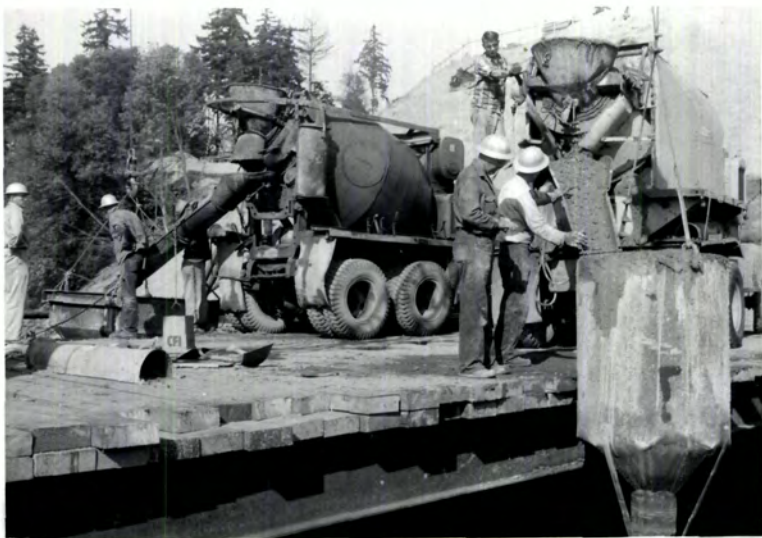
DATE: OCTOBER 11, 1957  
REMARKS: Tremie Pour Pier No. 9.

The placement of Class H tremie concrete was started at pier 9 on October 10, 1957. Concrete was transported to the site in transit mix trucks and dumped directly into the two tremie hoppers used to pour each seal. The tremie hoppers and pipes located near the one-third points of the cell, were raised and lowered by either a pair of cranes or a pair of stiff leg booms mounted on the work dock and operated by a double drum stationary Skaget hoist. Numerous problems were encountered on each tremie seal pour that required correction before the next one could be started. The Contractor's operations were improved on each successive pour as can be evidenced by the improved pour rate of the last pour over the first. The first tremie seal was made at the rate of 52 cubic yards per hour which resulted in an 8 inch lift per hour. On the last tremie seal, that at pier 4, the rate was 86 cubic yards per hour providing a lift of 15 inches per hour. After the tremie seals were placed, the cofferdams were de-watered and the top of the seal was cleaned up in the area of the pier columns and bottom strut. The tops of all seals were quite uniform in elevation, with the center one half nearly level. The end one quarters of each seal sloped downward slightly to the inside face of the column dowels. The concrete flow was then apparently restricted by the column dowels imbedded in the top five feet of the seal for the top surface was approximately two feet lower on all seals at the outside edges, adjacent to the column dowels. The last tremie seal concrete was placed on March 19, 1958 in Pier No. 4.

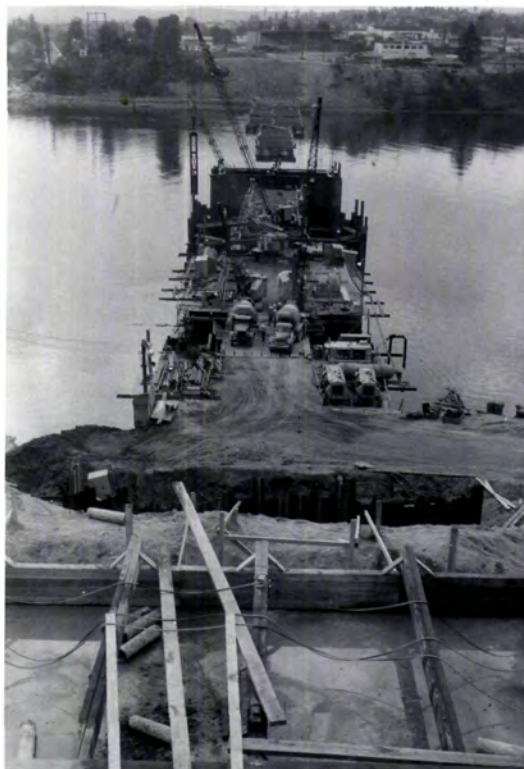
REMARKS: Strut forms in Pier No. 10.  
Frame members were imbedded  
in the strut.

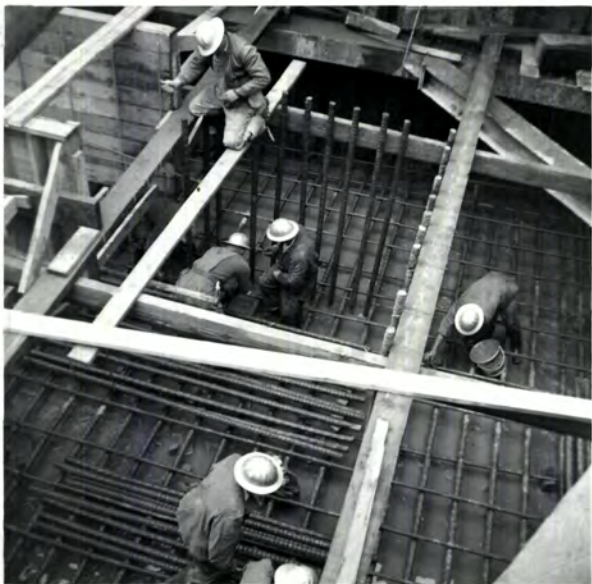
DATE: OCTOBER 18, 1957  
REMARKS: Pier No. 10 cofferdam after footings and bottom strut had been poured. Note bracing to hold north line of piling.

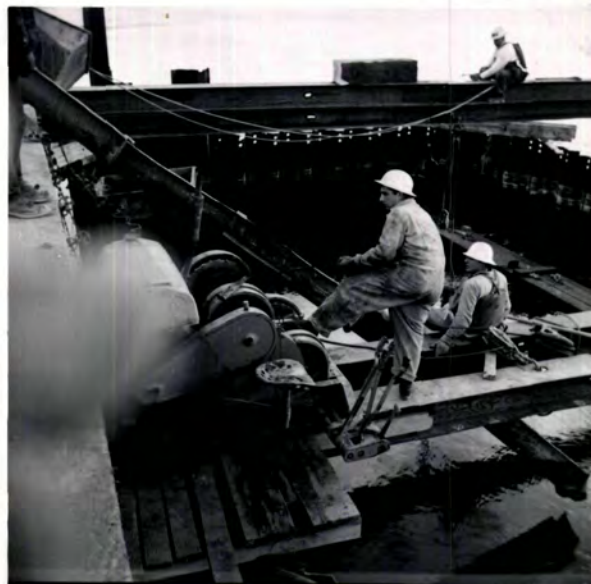
...DATE: NOVEMBER 26, 1957  
REMARKS: Clean-up and chipping Cell No. 7  
to eliminate sand seam discovered  
when drilling for column dowels.

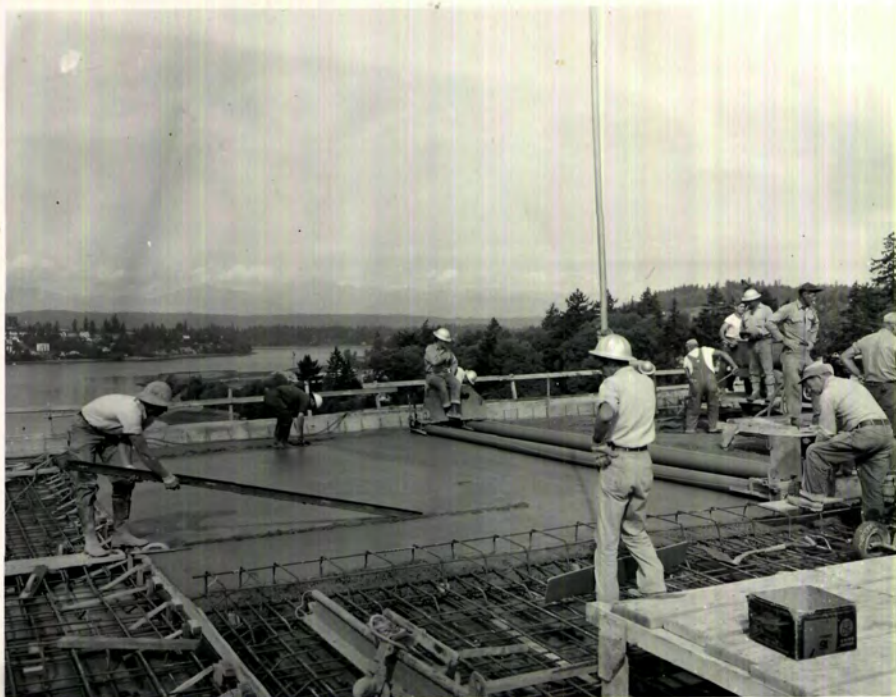
REMARKS: Placing lightweight  
concrete in second  
section of steel span  
North of Pier No. 5.  
Note Clary screed and  
removal of flush screed.

The construction of the concrete T-beam and box girder portions of the superstructure began in March of 1958. This work proceeded in a usual manner to completion in August of 1958. Roadway deck slabs were finished with a Clary screed and Master vibrating rod, operating on channel screeds set flush with the top surface of the concrete. The finishing machines were operated lengthwise on the deck, one on each side of centerline. The roadway deck slabs were placed during the hottest weather recorded in Bremerton during the past several years. The concrete was taking its initial set as close as ten feet behind the finishing machines, making it virtually impossible to attain a deck with better than average riding qualities.

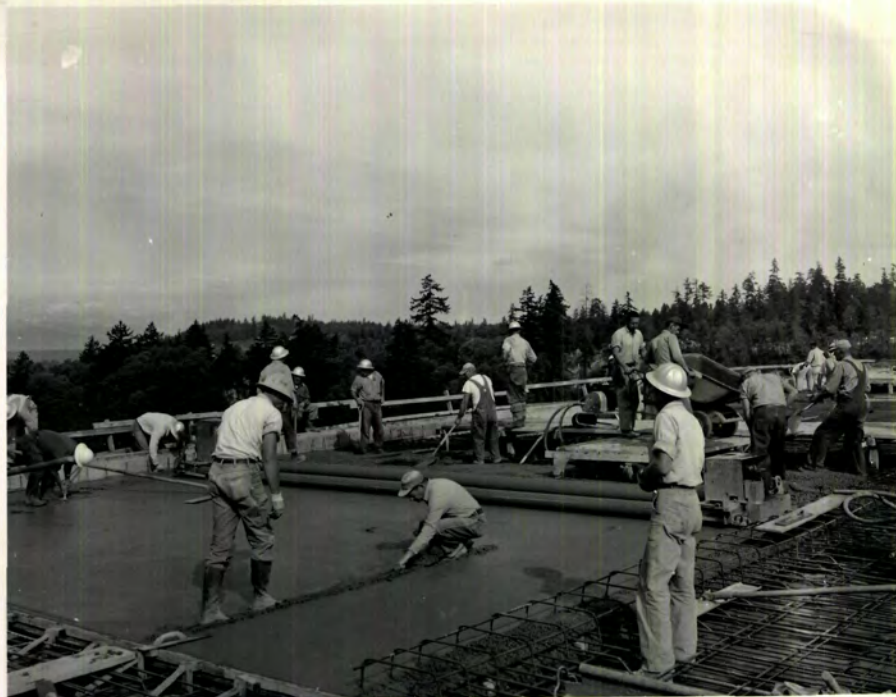
REMARKS: Lightweight concrete deck in fourth and sixth sections North of Pier No. 5. Master vibrator used on East half and Clary screed on West half.

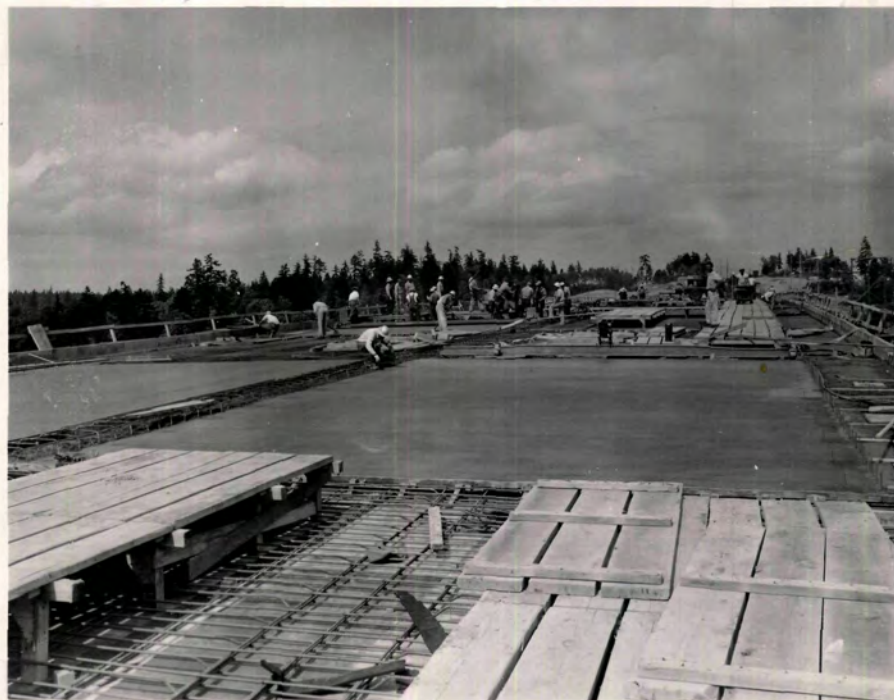
REMARKS: Finish on lightweight concrete roadway slab.
